Subpectoral pacemaker implant after repeated pocket complications due to “senile pruritus”

Andreea-Maria Ursaru¹, Andreea-Mihaela Ignat^{*,1}, Dana Corduneanu², Gabriel Mazilu³, Antoniu Octavian Petriș^{1,4}, Dan-Nicolae Tesloianu¹

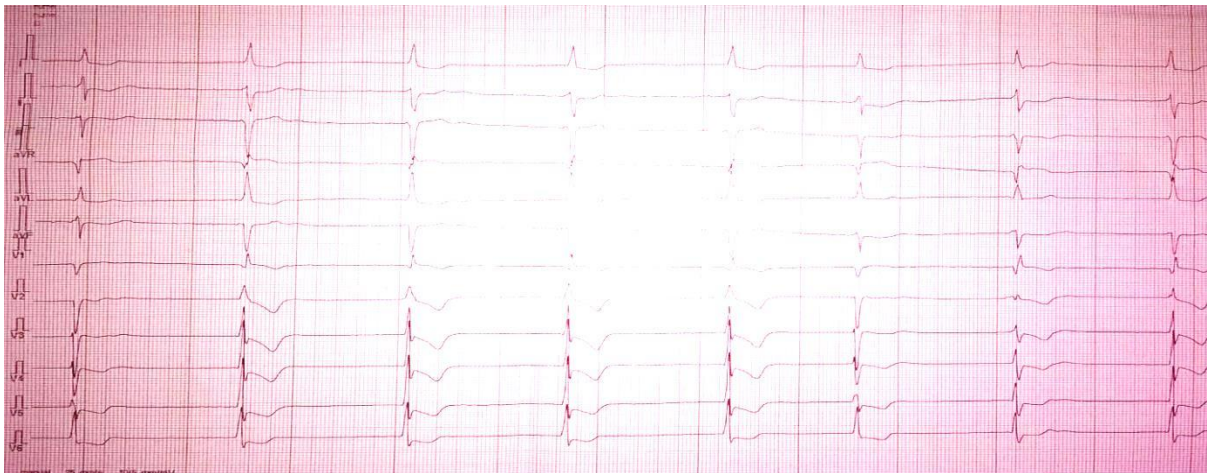
Fig. 1. Electrocardiogram recording showing slow atrial fibrillation with intermittent AV block with idioventricular escape rhythm with right bundle branch block pattern

An 89-years old patient, known with atrial fibrillation, was transferred in June 2016 to the Cardiology Department, after detecting on the electrocardiogram recording very slow heart rate (30 beats per min) (Figure 1). The patient was receiving chronic digitalis therapy, but the digoxin had been interrupted eight days before the moment of admission to our hospital. He was confused and temporo-spatial disoriented. Biochemical parameters revealed severe azotate retention, with a creatinine clearance of 20 ml per minute.

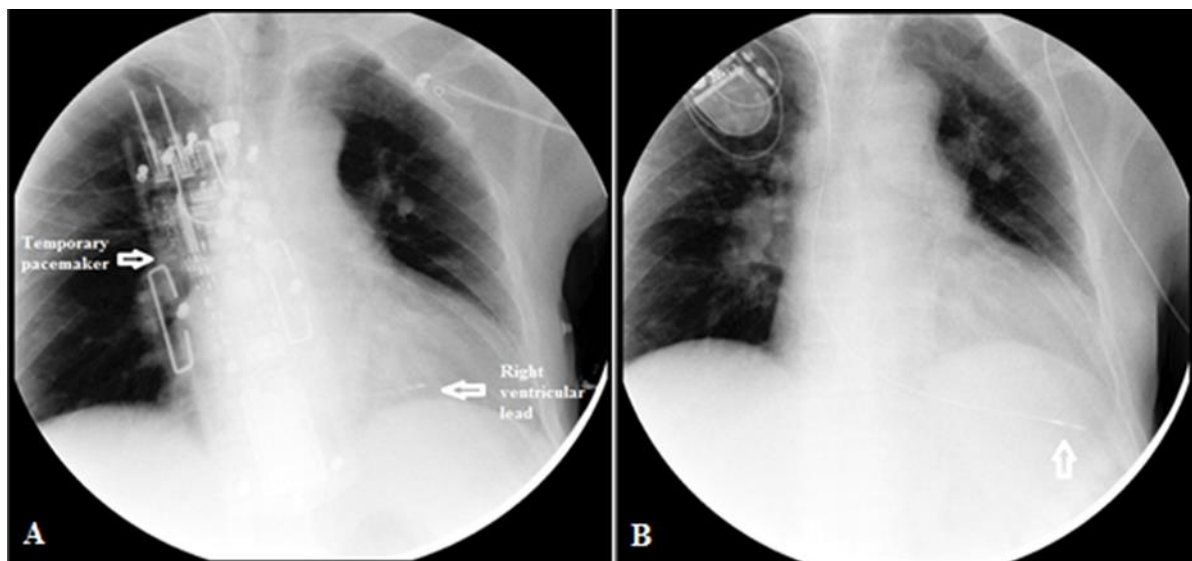
Fig. 2. Posteroanterior chest X-ray film: external temporary pacing (A), followed by a permanent pacemaker implant (B)

systolic function (an ejection fraction of 25%), and medium secondary pulmonary hypertension (PAPS 55-60 mmHg), were the pathological findings at transthoracic echocardiography examination. His altered mental status and the slow heart rate entailed emergent temporary transvenous pacing (Figure 2A). After five days, at the attempt to stop temporary pacing, the patient maintained very slow heart rate - 35 beats per minute. Even though, it wasn't measured the digoxin serum level, after thirteen days (eight days before admission and five days during

hospitalization) of digitalis interruption, it was concluded that the patient had enough time to eliminate the drug. Therefore, because the patient had a mean heart rate of 35 beats per minute, it was decided to perform a permanent unicameral VVIR pacemaker implant (Endurity Core SSI, St. Jude Medical), using right subclavian vein approach. Before procedure, written consent was obtained from his family. An active fixation lead-Trendil STS 2088TC/58, St. Jude Medical-was placed in the right ventricle (Figure 2B - arrow), with acute threshold of 0.25 V at 0.4 ms.

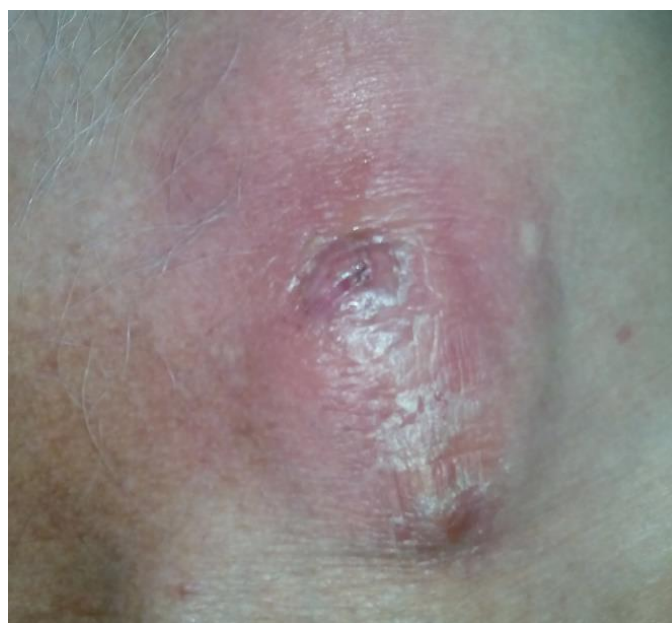
Fig. 3. Local infection at the pacemaker pocket

The patient returned for the two weeks and three months post-implant visits, having optimal electric parameters and a healed wound. Six months after the implant, the patient addressed again to our Department, for signs of inflammation at the pacemaker pocket (local tumefaction and hyperemia), with purulent secretions (Figure 3). At physical examination we also discovered multiple excoriations extended on his entire body, with areas of lichenification. The patient was afebrile and he was complaining of intense pruritus. His ECG revealed atrial fibrillation with a ventricular rate of 80 beats per minute, with intermittent periods of pacemaker dependency (Figure 4). The pacemaker interrogation showed 54% ventricular paced rhythm and 46% ventricular sensed rhythm. Biochemical laboratory investigations demonstrated a stable chronic kidney disease (creatinine clearance of 38 ml/min). A nonspecific inflammatory syndrome (C-reactive protein 2.86 mg/dl, fibrinogen 423 mg/dl) and a moderate normocytic

Because of his advanced age and his non-compliance to treatment measures, it was decided to keep the same generator pocket, although the patient had indication to remove the whole pacemaker system, and to place a new one on the other side. After collecting secretion samples, a broad-spectrum antibiotherapy (Vancomycin 500 mg q 24h and Ceftriaxone 1000 mg q 8h) was initiated, drug dosage being adapted to creatinine clearance. Next day, in the electrophysiology cardiology laboratory, under local anesthesia, two small incisions were performed at the pacemaker pocket. The intervention continued with the drainage of the purulent secretions and antiseptic lavage, followed by large sutures that closed the wound. The secretion test results indicated *Staphylococcus aureus* with high sensitivity to antibiotics. Therefore, prior antibiotherapy was replaced with Oxacilin 1000 mg q 6h, in concordance with antimicrobial susceptibility.

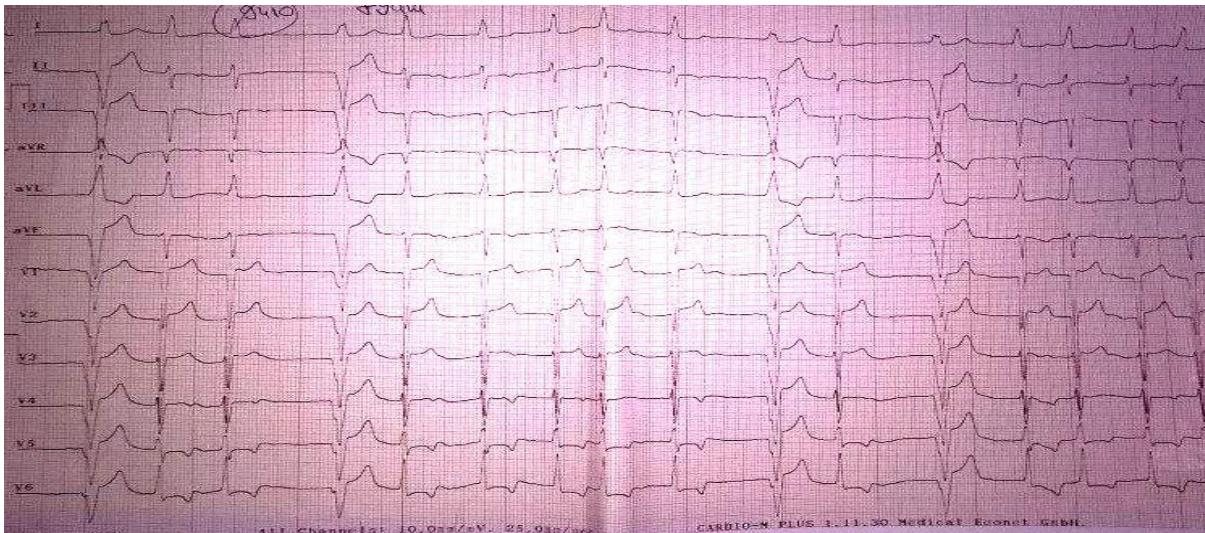
Fig. 4. Electrocardiogram recording: atrial fibrillation alternating with ventricular paced rhythm

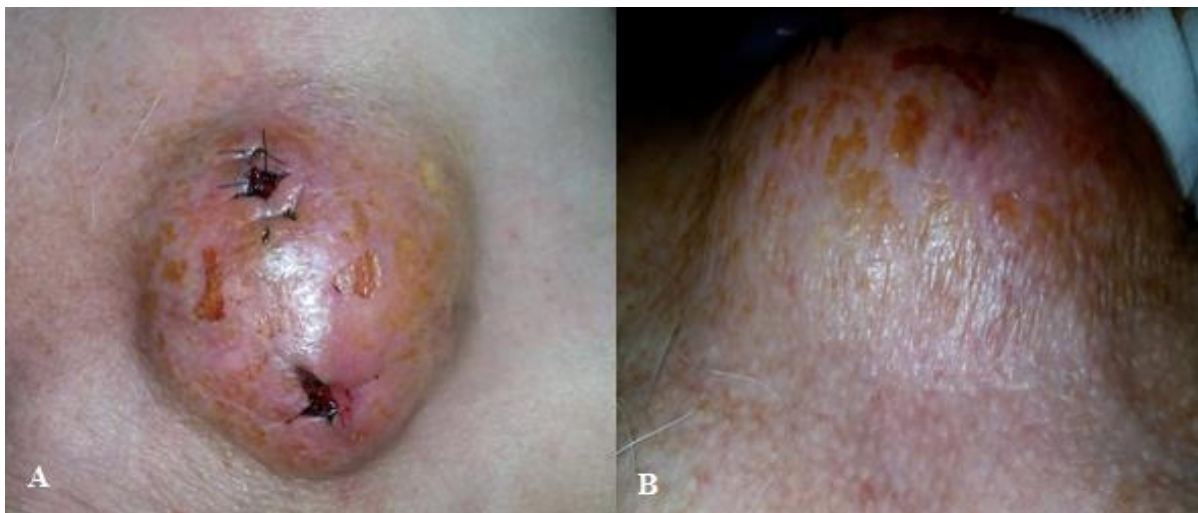
methods of bandage and correct dermatological treatment, even under sedation with Alprazolam. Repeated Velpeau bandages were performed, but each time he succeeded to untie it with his cane. Moreover, due to chronic pruritus, he developed pocket hematoma (Figure 5).

Fig. 5. Pacemaker pocket hematoma

Anticoagulant therapy with Enoxaparine was interrupted in the same day after the complication occurred. Because hematoma was expanding, being tense and painful, it demanded surgical revision to identify and arrest the site of bleeding. Assisted by a

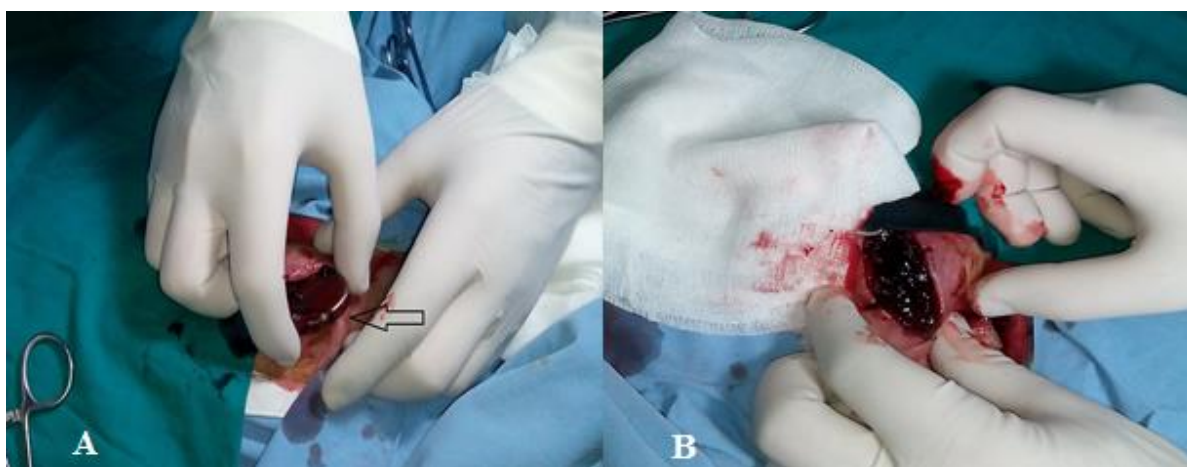
Fig. 6. Generator removal (A-arrow) and then, manual evacuation of blood clots (B)

plastic surgeon, the sutures were removed for clots drainage. First, the pacemaker was extracted from its pocket, and then the blood clots were gentle evacuated. After lavage with antiseptic solutions, the generator was reintroduced in its prior location (Figure 6).

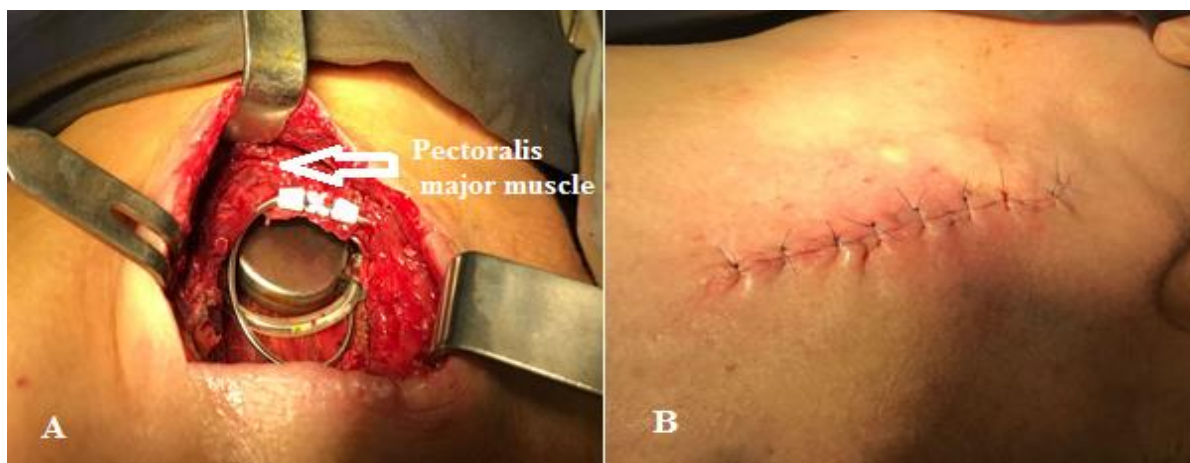
Fig. 7. Pectoralis major muscle-splitting approach to subpectoral place with generator insertion (A) and immediate closure after procedure (B)

Because there was a high risk of reinfection (persisting pruritus to a non-compliant patient), after another four days, we decided to relocate the device on the same side, beneath the pectoralis major muscle. Being no signs of deep local infection it was decided to use the same pacemaker pulse generator. The procedure demanded a pectoralis major muscle spreading incision. Using a blunt dissection, a subpectoral pocket

was developed, without affecting pectoralis minor muscle. Once a satisfactory subpectoral pocket was created, the generator unit was placed in it (Figure 7A), and then the muscle was primarily closed over the device. Meticulous layered closure of the subcutaneous tissue was performed to obliterate dead space in the original superficial pocket (Figure 7B). Bacteriology report of the wound secretions revealed no growth.

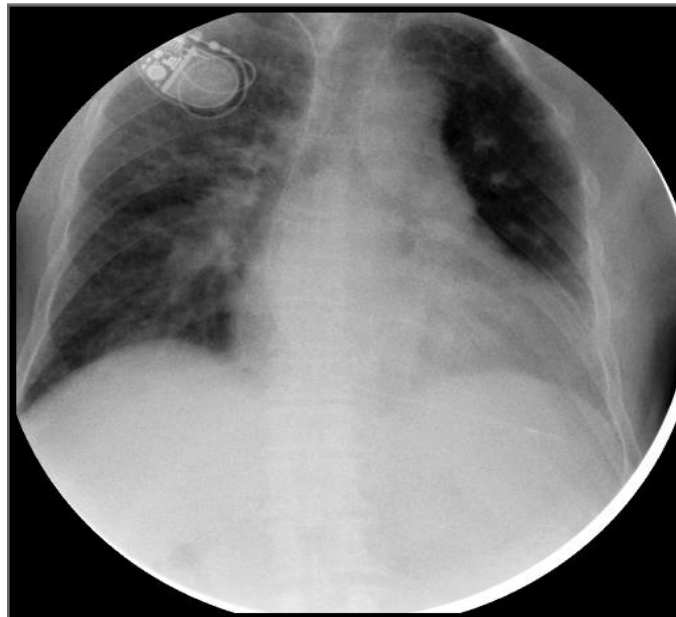
Fig. 8. Posteroanterior chest X-ray film showing the generator's new position

Post-procedural, a chest X-ray confirmed the new location of the pacemaker (Figure 8).
